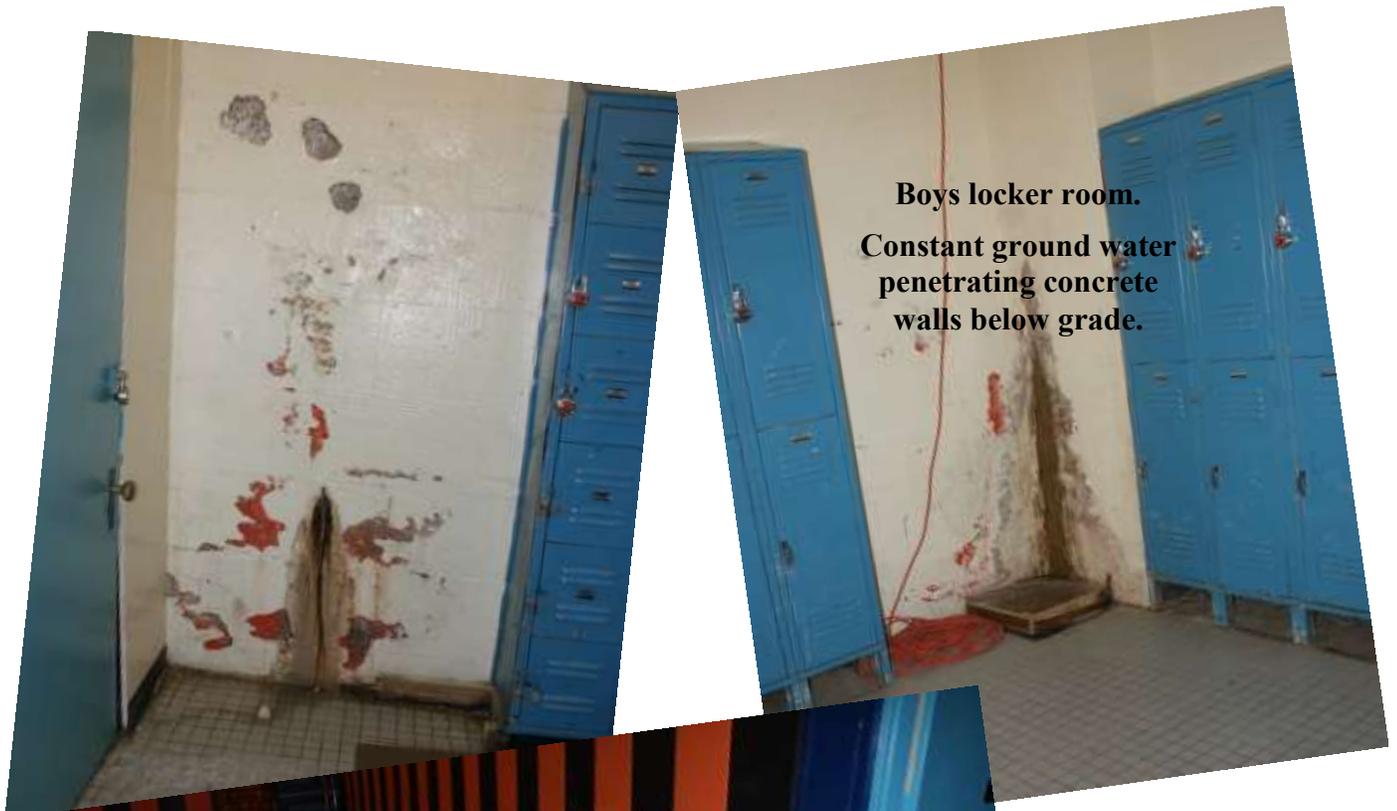
**Boys locker room.  
Constant ground water  
penetrating concrete  
walls below grade.**

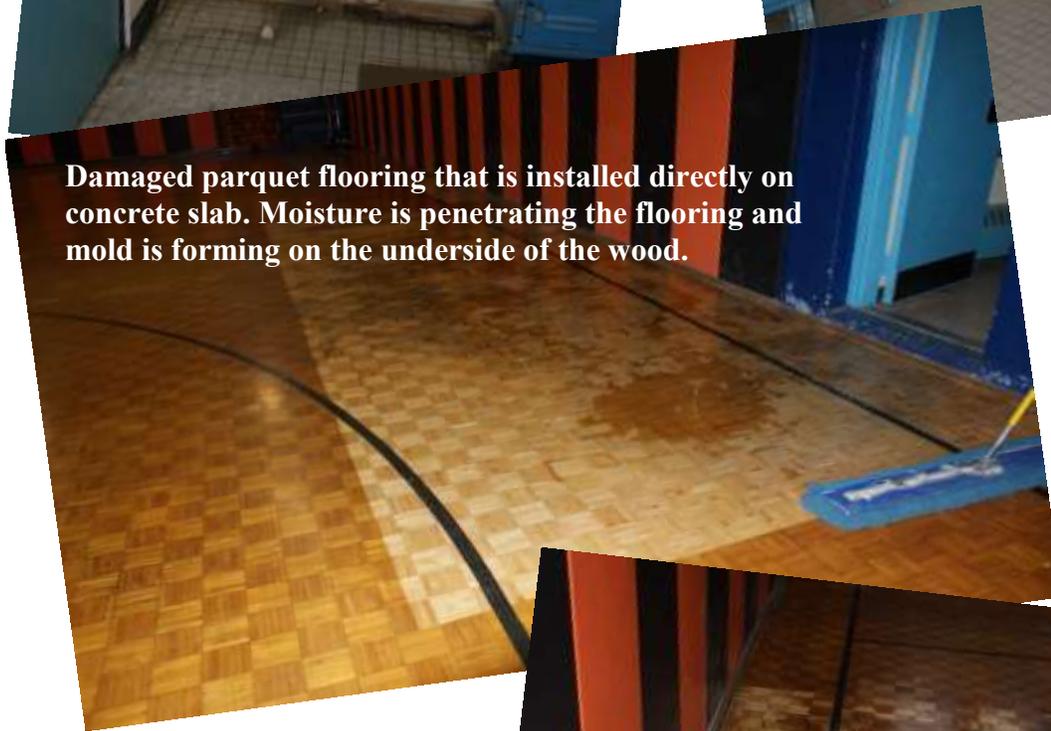
**Damaged parquet flooring that is installed directly on  
concrete slab. Moisture is penetrating the flooring and  
mold is forming on the underside of the wood.**

**The finish on the floor is  
removed in these areas  
during summer cleaning  
and allowed to dry out then  
resealed.**

**The parquet flooring is an odd  
size and is no longer available.  
Maintenance has to fabricate  
the flooring strips.**

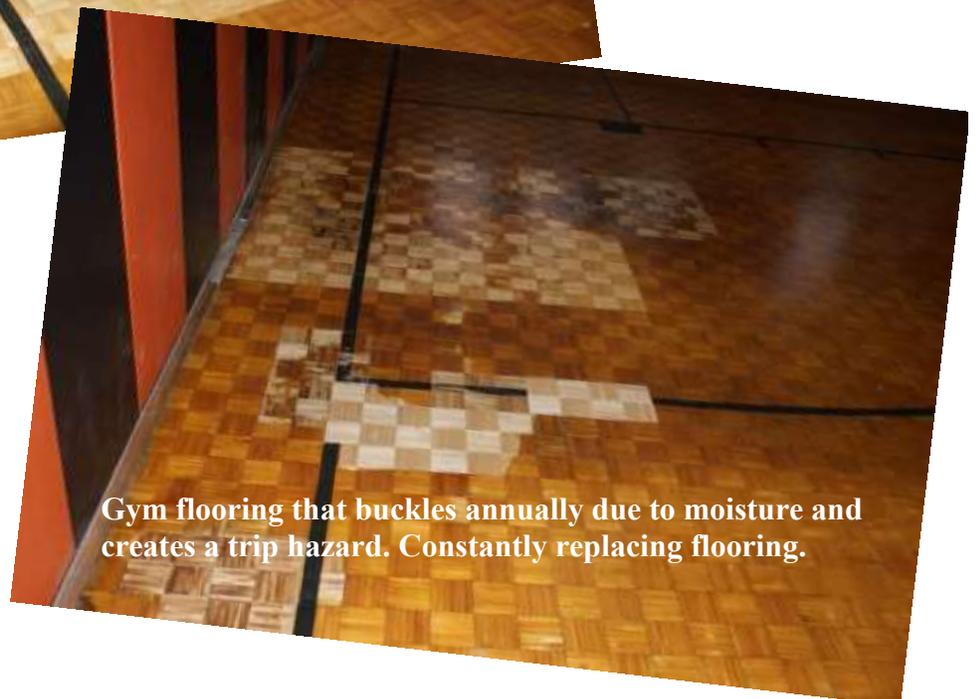
**Gym flooring that buckles annually due to moisture and  
creates a trip hazard. Constantly replacing flooring.**

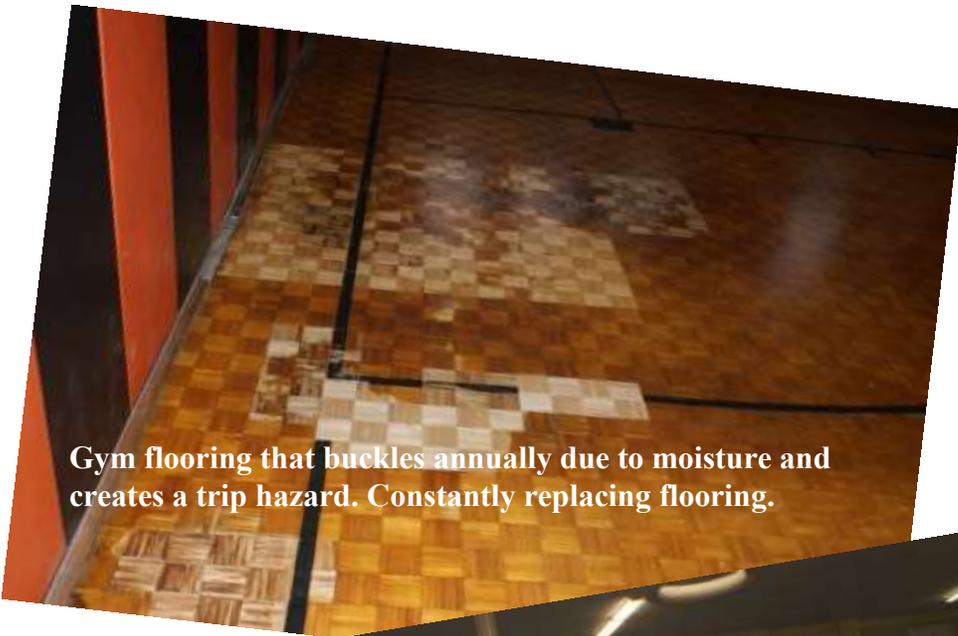
**Gym flooring that buckles annually due to moisture and creates a trip hazard. Constantly replacing flooring.**

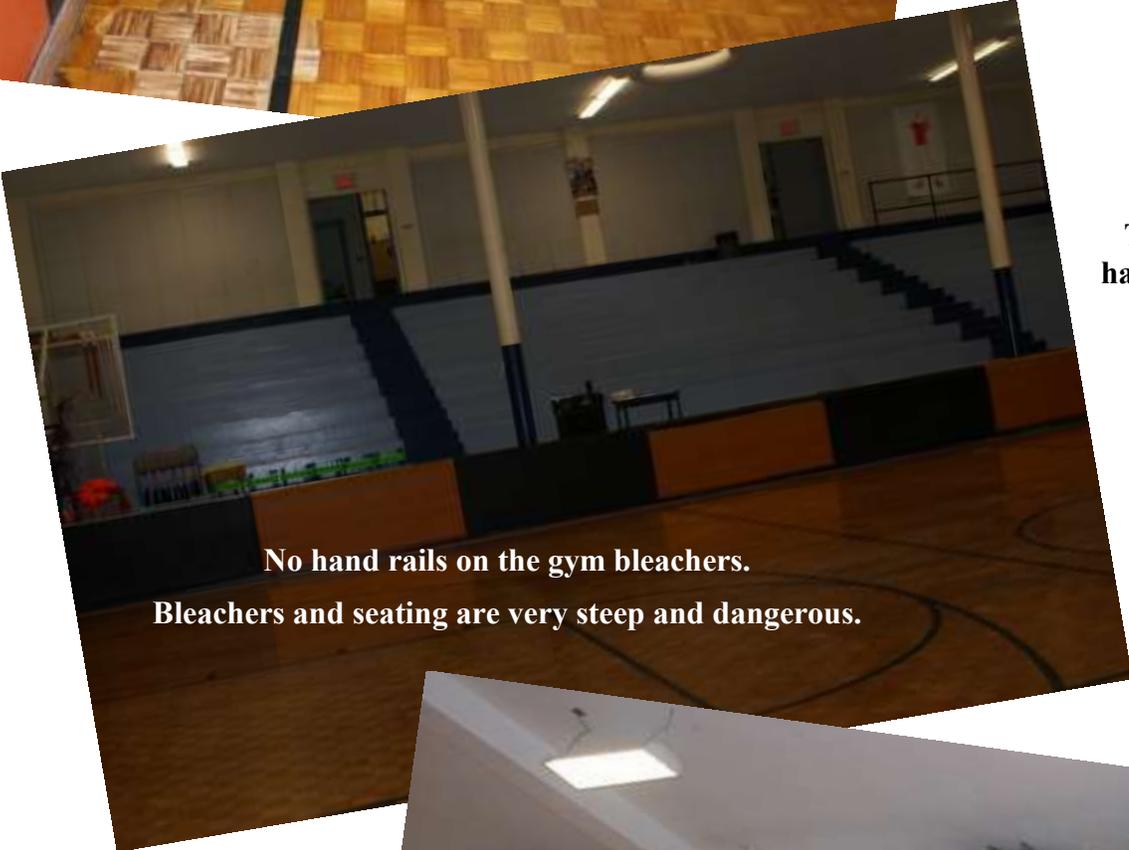
**No hand rails on the gym bleachers.  
Bleachers and seating are very steep and dangerous.**

**The gym is not ADA  
handicapped accessible.**

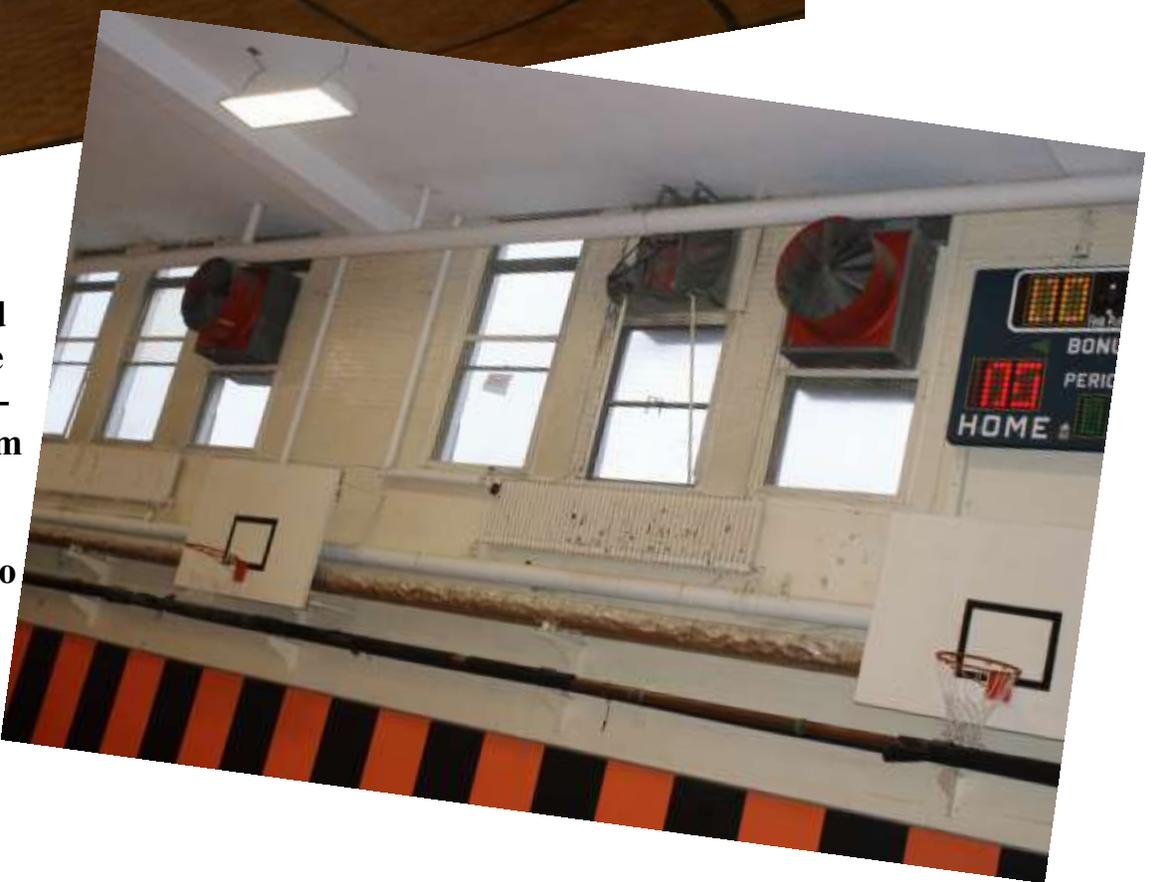
**Manually operated  
exhaust fans in the  
gym. Fans are covered  
with Styrofoam  
and plastic in the  
winter to prevent  
freezing. There is no  
fresh air returns.**

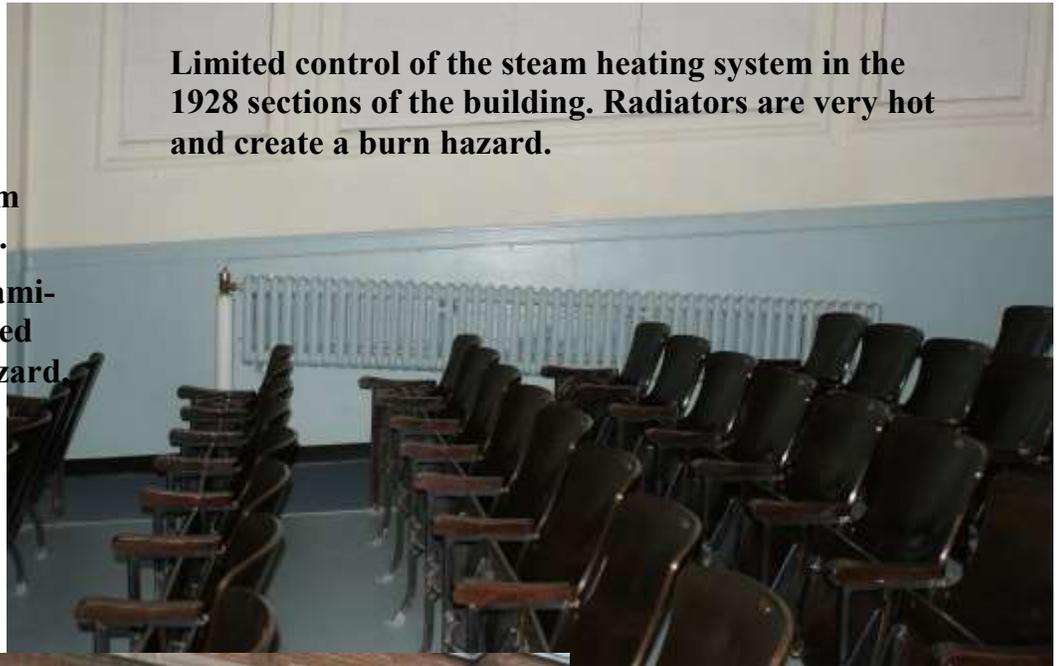
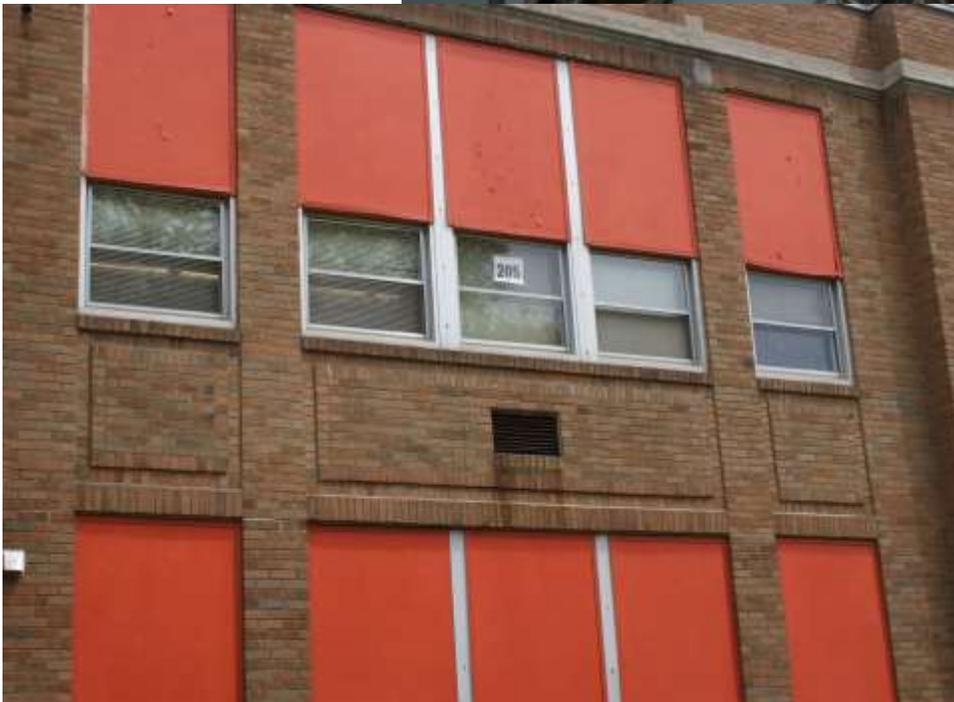
**The seating in the auditorium has become a safety concern.**

**The wood has started to delaminate and splinter. The exposed metal hinge is a pinching hazard.**

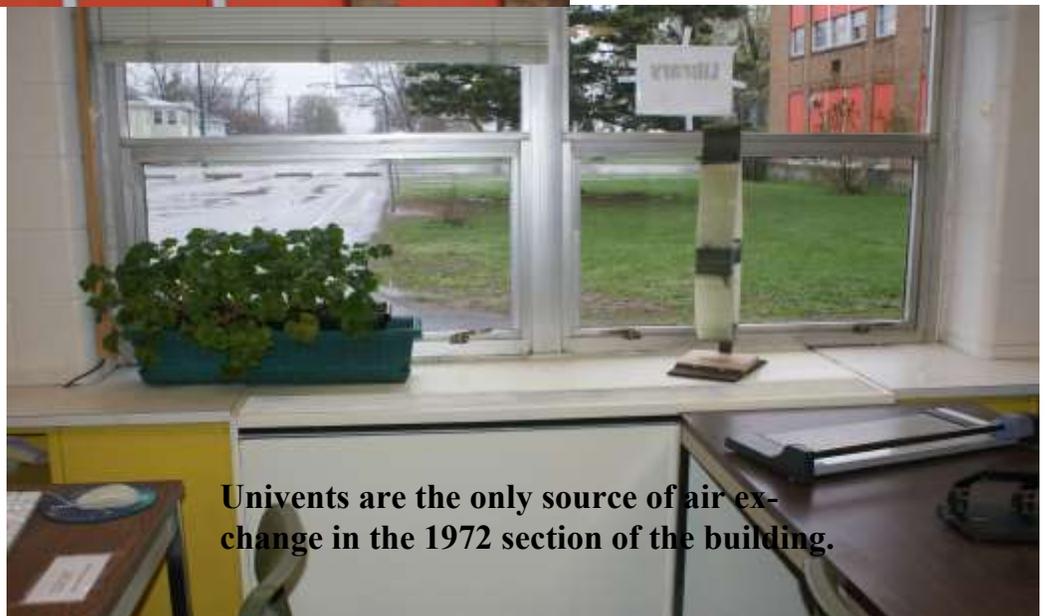
**The large windows of 1928 section of the building have been replaced with a smaller aluminum framed single pained window. The plywood exterior sections need constant repairs**

**Windows are a single pane non-insulated glass. There are no screens to prevent insect from entering the building. This is a real danger to the children with allergies.**

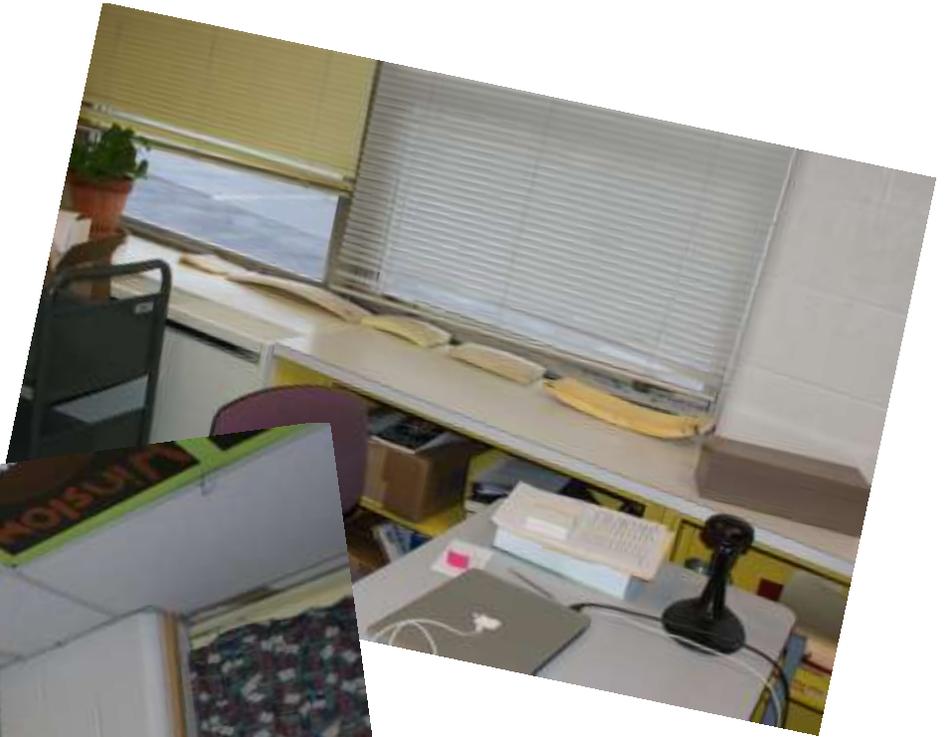
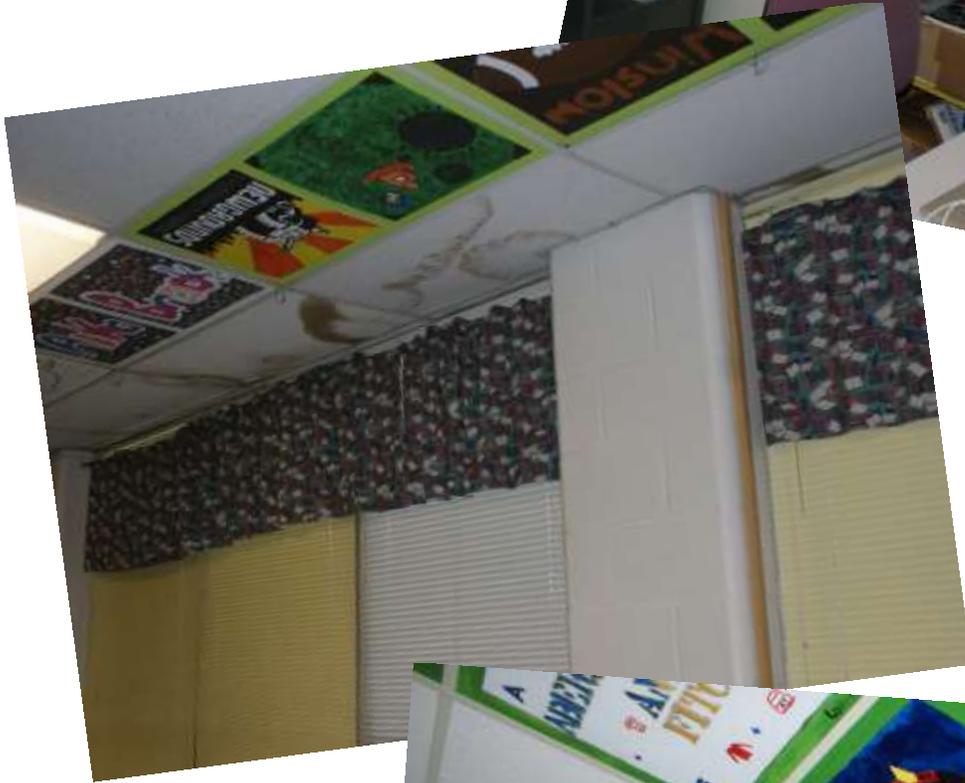
**Univents are the only source of air exchange in the 1972 section of the building.**

**All windows in the 1972 section of the building leak and are very cold. When it rains sponges are kept on the shelves to prevent additional damages in the Library and other areas.**

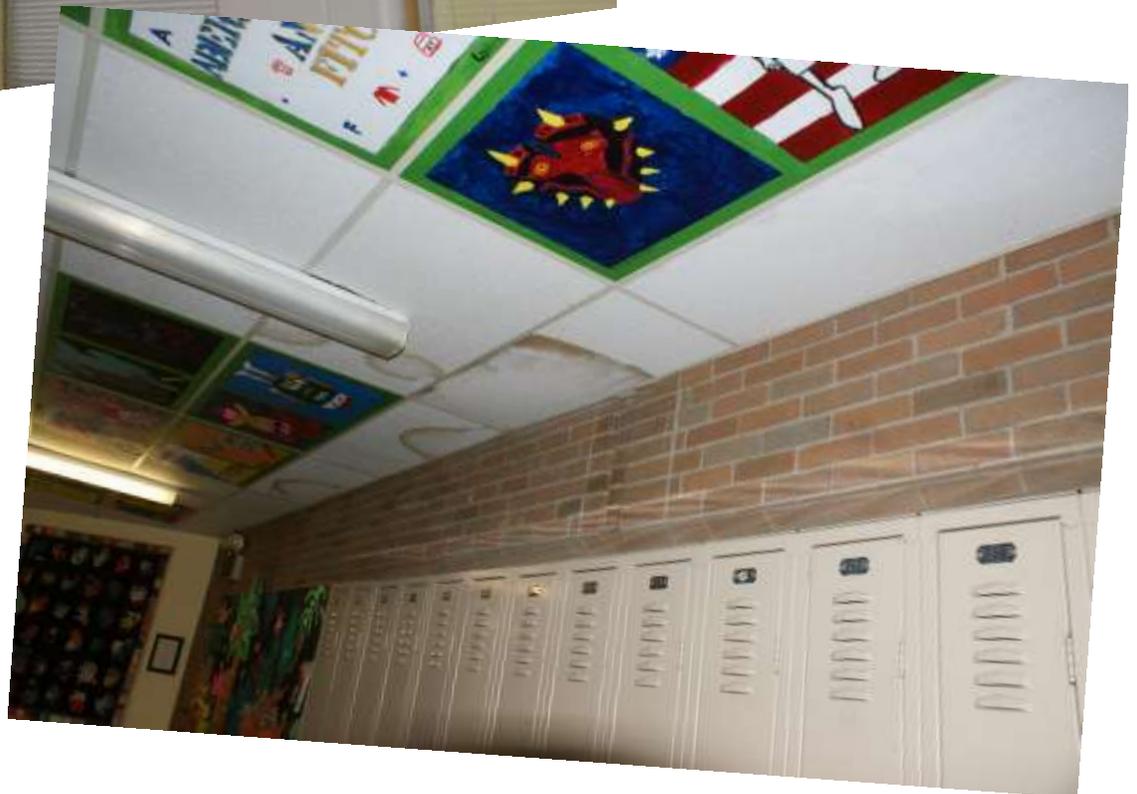
**The staining seen here is from the second story windows. The window sections are built as part of the primary wall. Caulking maintenance is done all year to help prevent the**

**The roof flashing is failing between the 1928 and the 1972 sections of the building. This has created leaking in these areas. We have made several attempts to resolve this problem.**

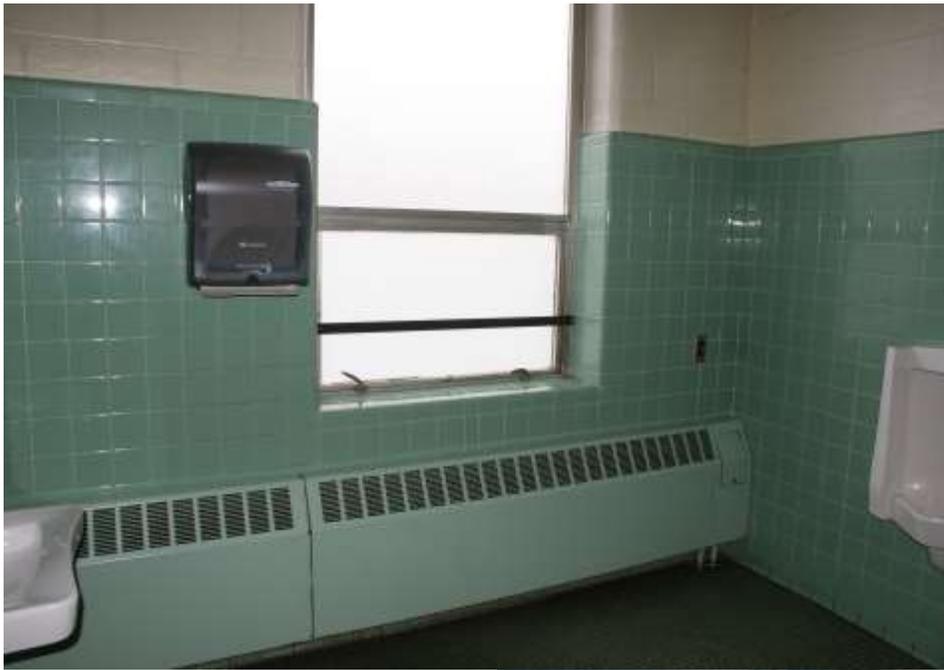
**Window in boy's bathroom is screwed shut The boys would crawl through the window and play on the roof. This has limited the ventilation in the restroom.**

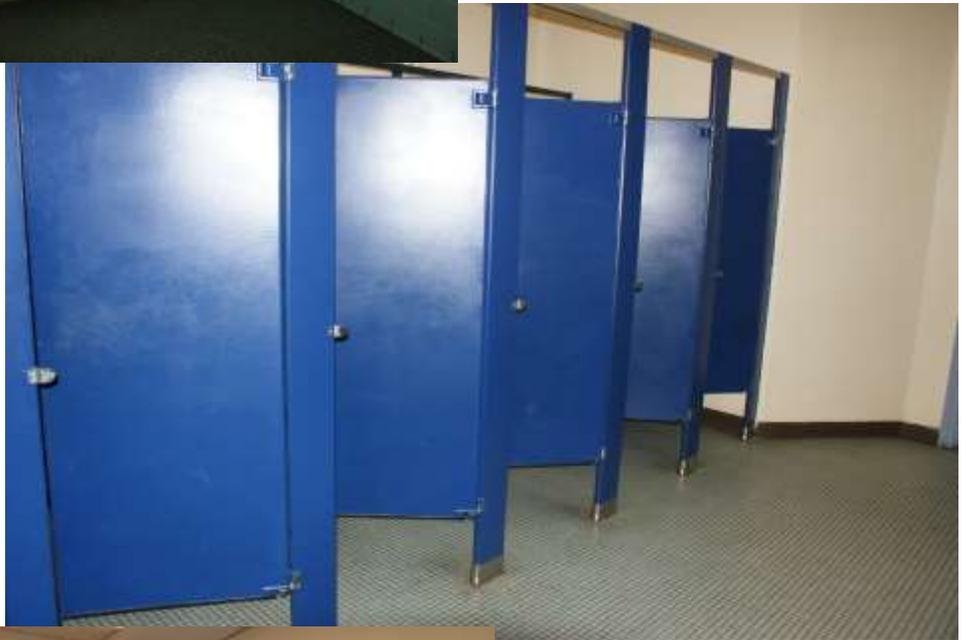
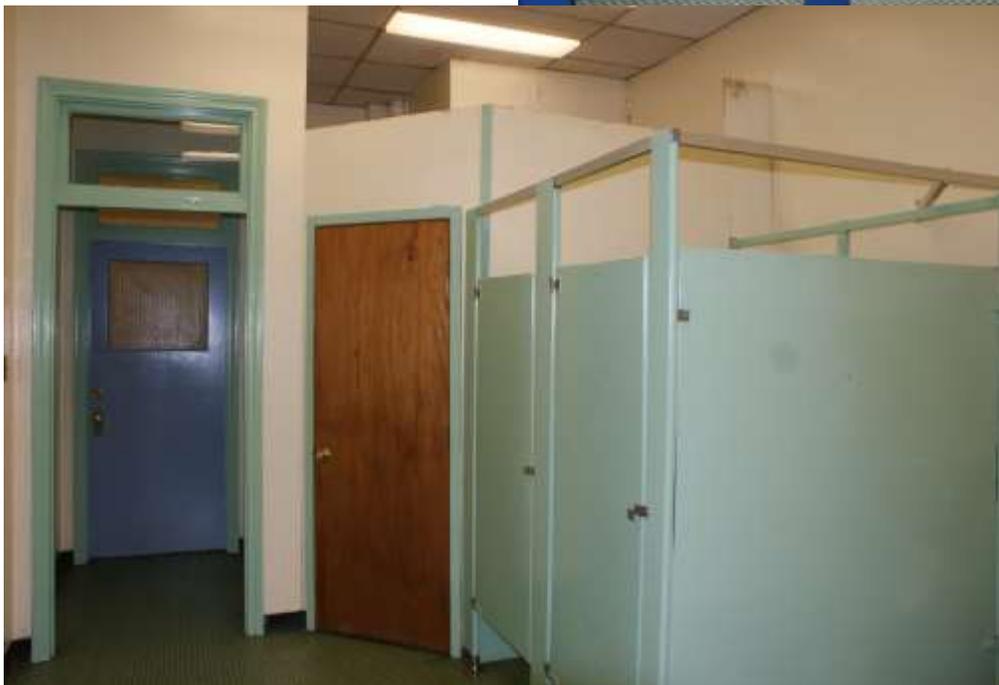
**Makeshift storage areas have been created for custodians to store cleaning products in the bathrooms.**

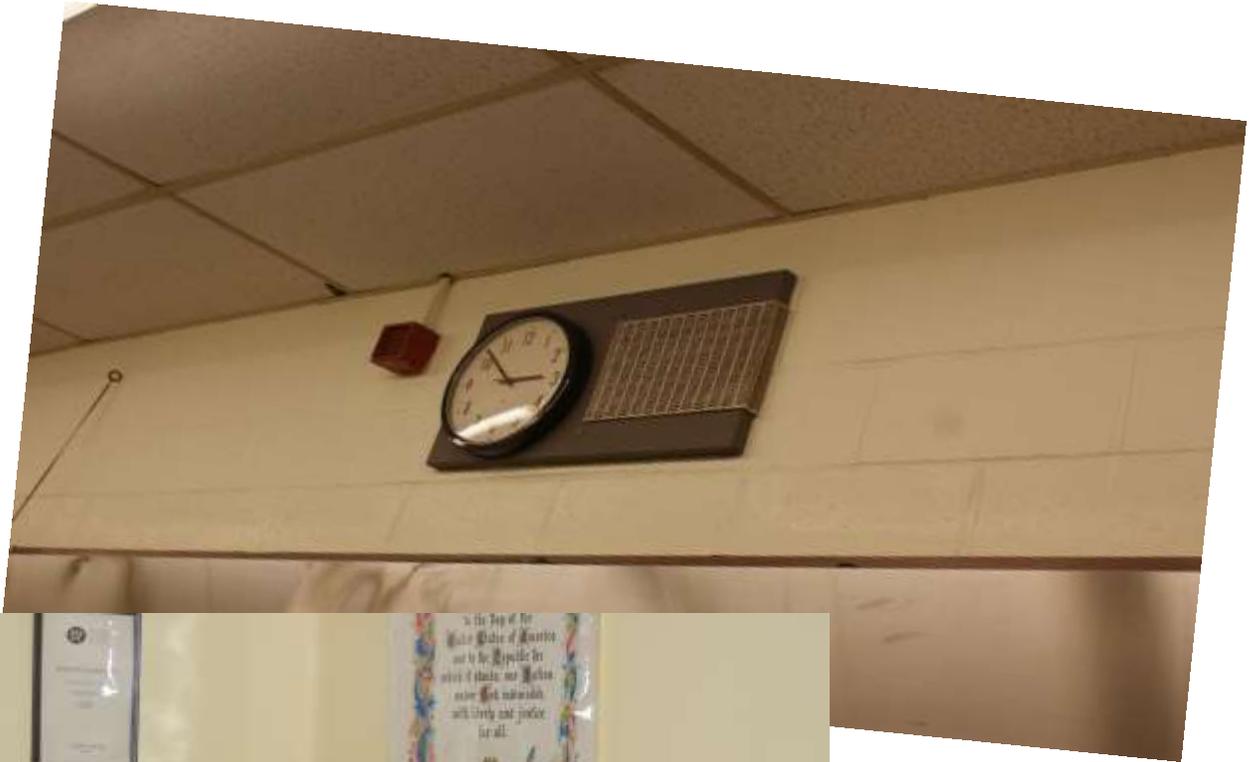
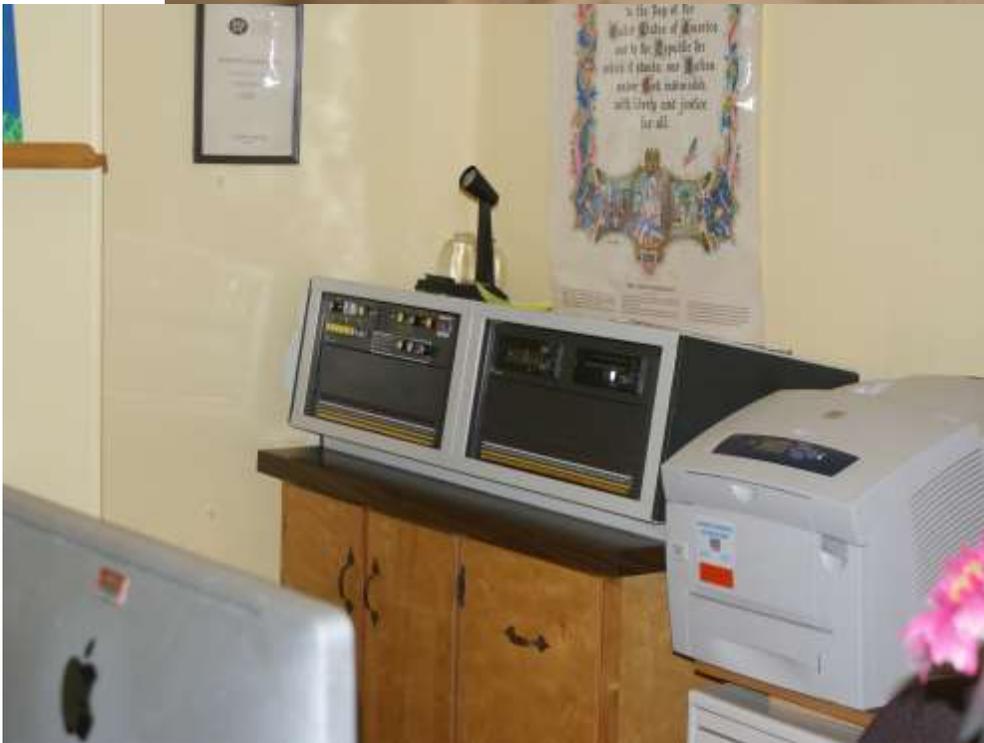
**An unreliable antiquated intercom system. System has failed on many occasions. Operates sporadically. System is at the end of it's life. Parts are no longer available.**

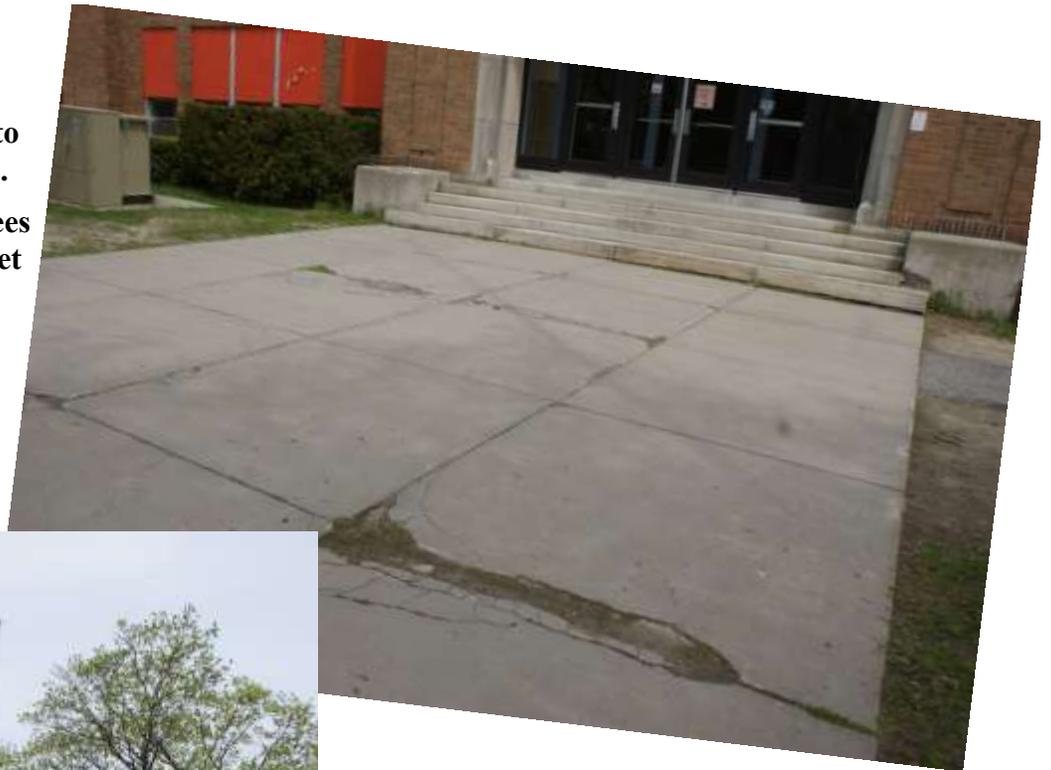
**Front cement walkway has become a trip hazard due to settling and deteriorating concrete.**

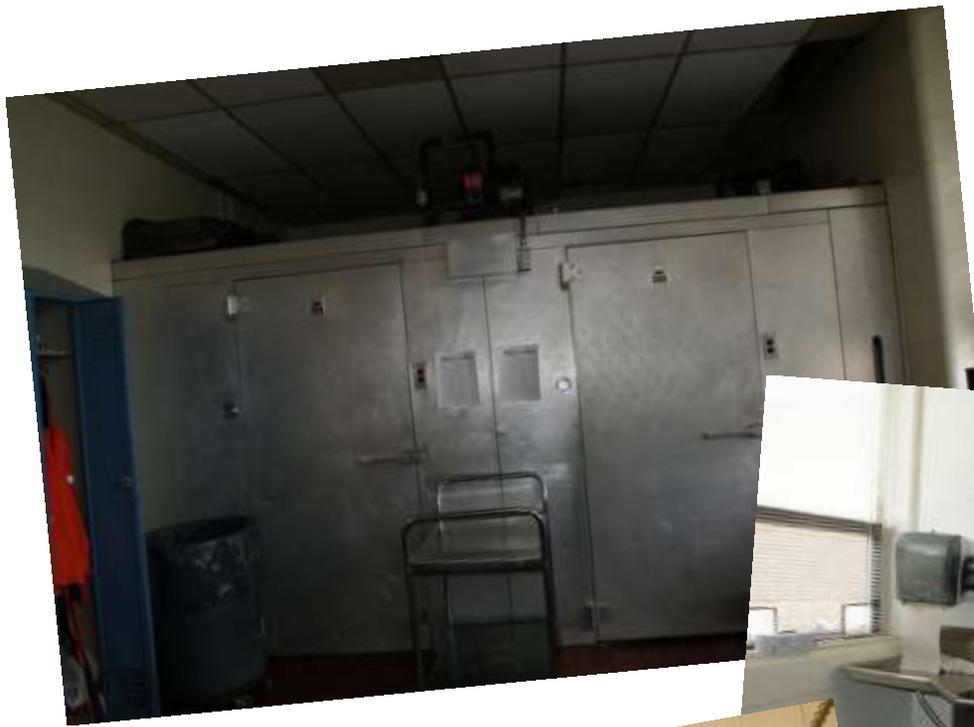
**Walk in freezers and coolers have outlived their life expectancy. The size of the units are no longer adequate and require constant repair.**

**The refrigeration units are inside the kitchen area and on top of the units and generate a considerable amount of heat.**

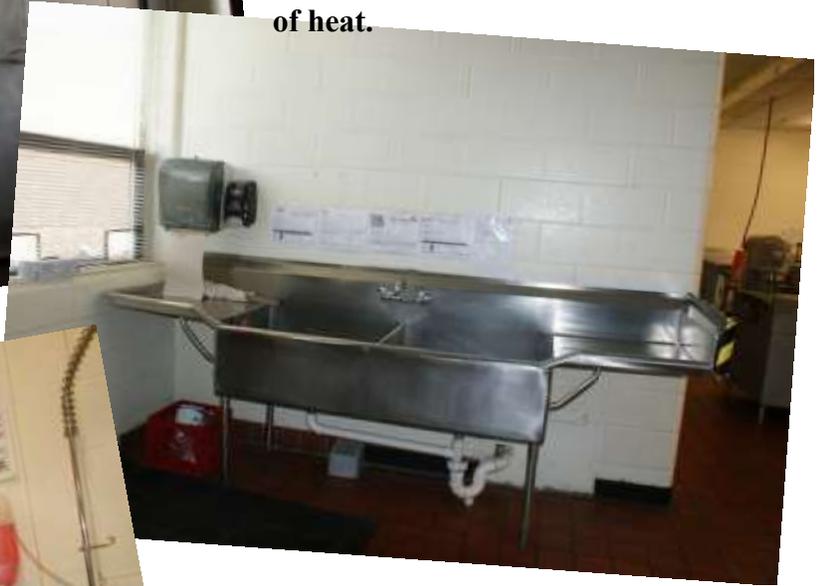
**Wash sinks do not meet the Health & Safety standards of the State of Maine.**

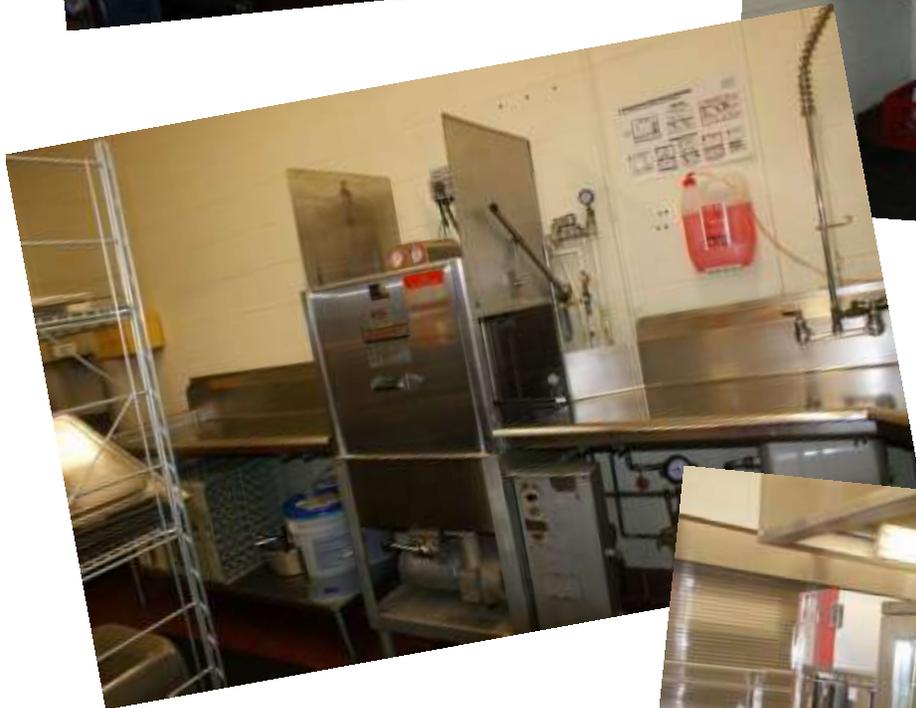
**Kitchen equipment is outdated and difficult to maintain. Repairs are not always an option due to parts being unavailable.**

**The equipment in this kitchen is all electrical and was installed during the 1972 renovation.**

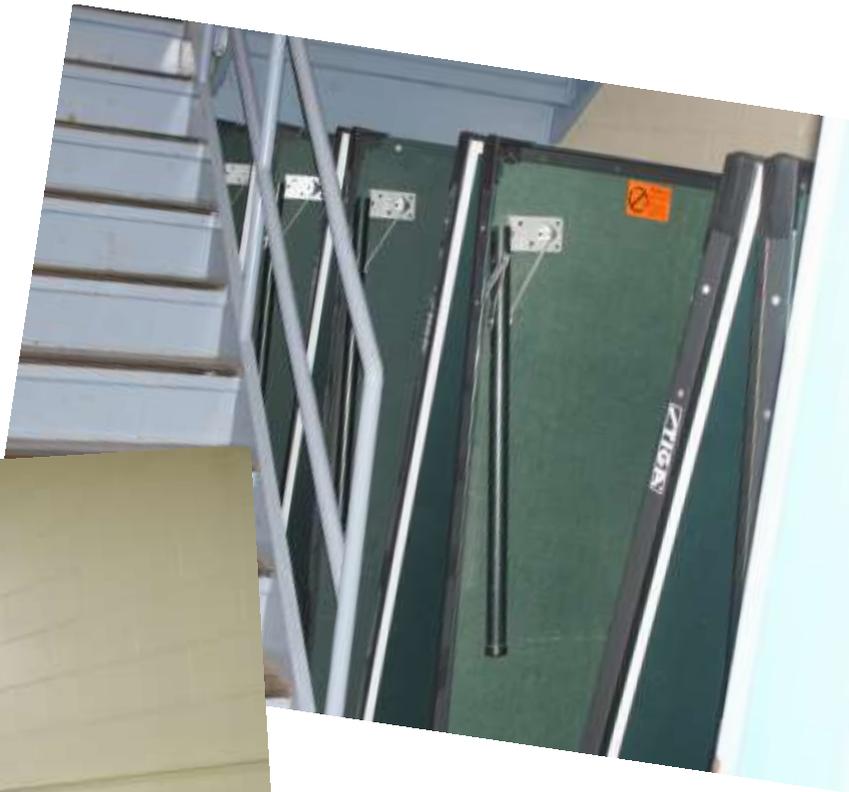
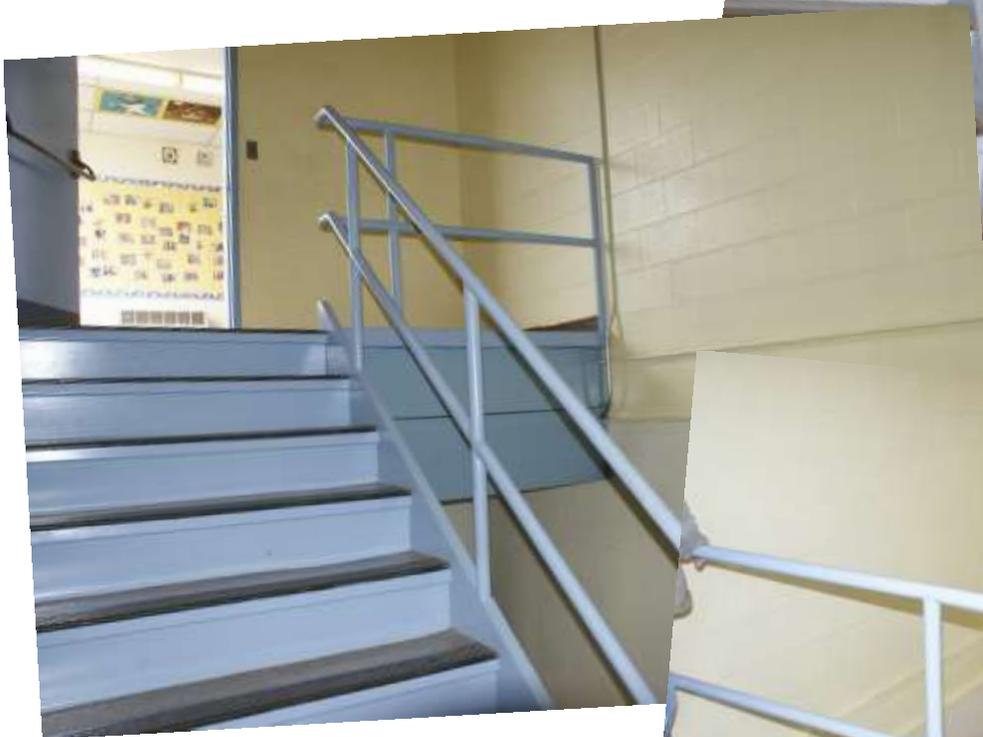
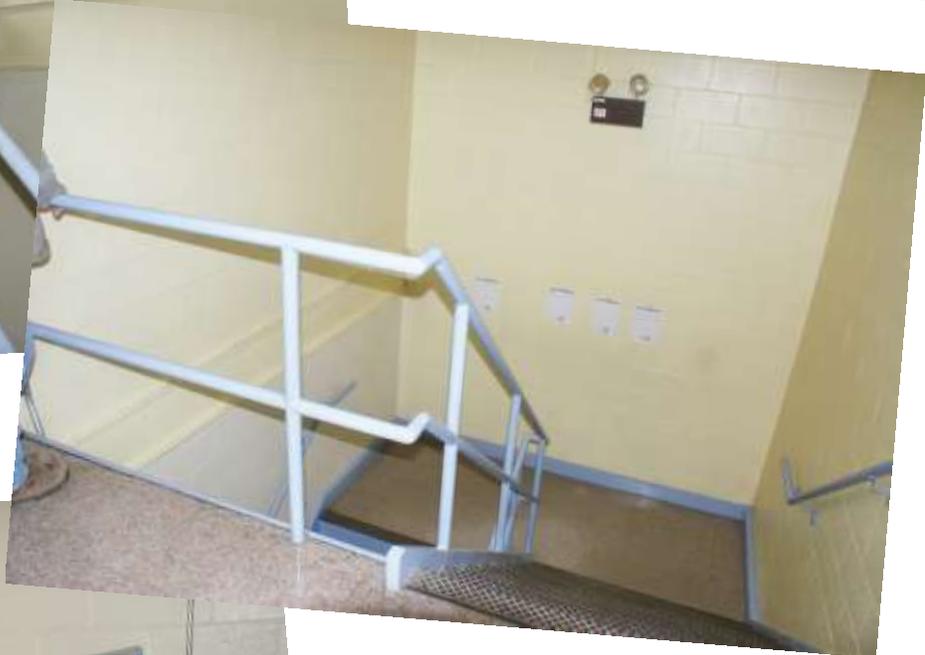
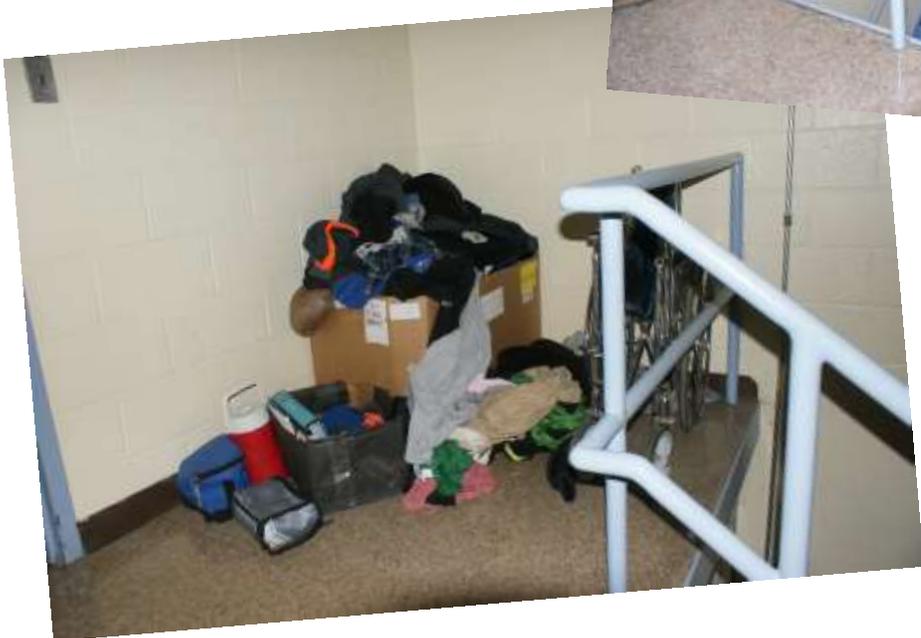
**Open stair rails are a huge liability and risk to children of all ages.**

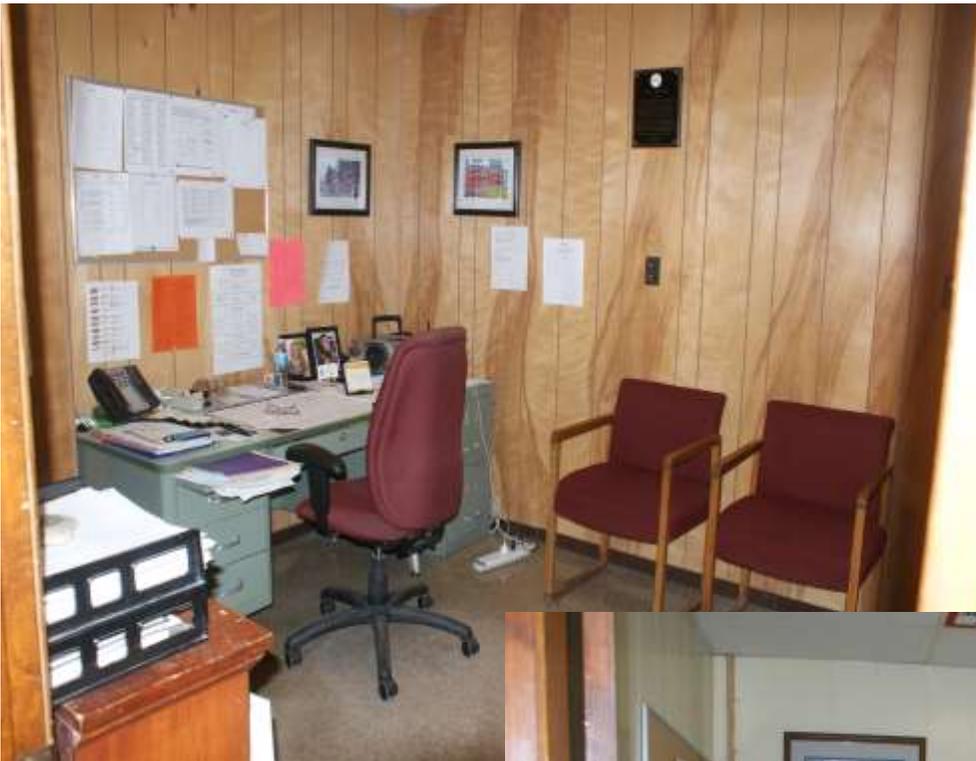
**Administration offices are small and unaccommodating. Difficult to meet with multiple parents of children with concerns or needs. Privacy is not always assured due nonconforming hollow core doors.**

**Seating and ventilation is very limited in these areas. There are no windows to provide fresh air.**

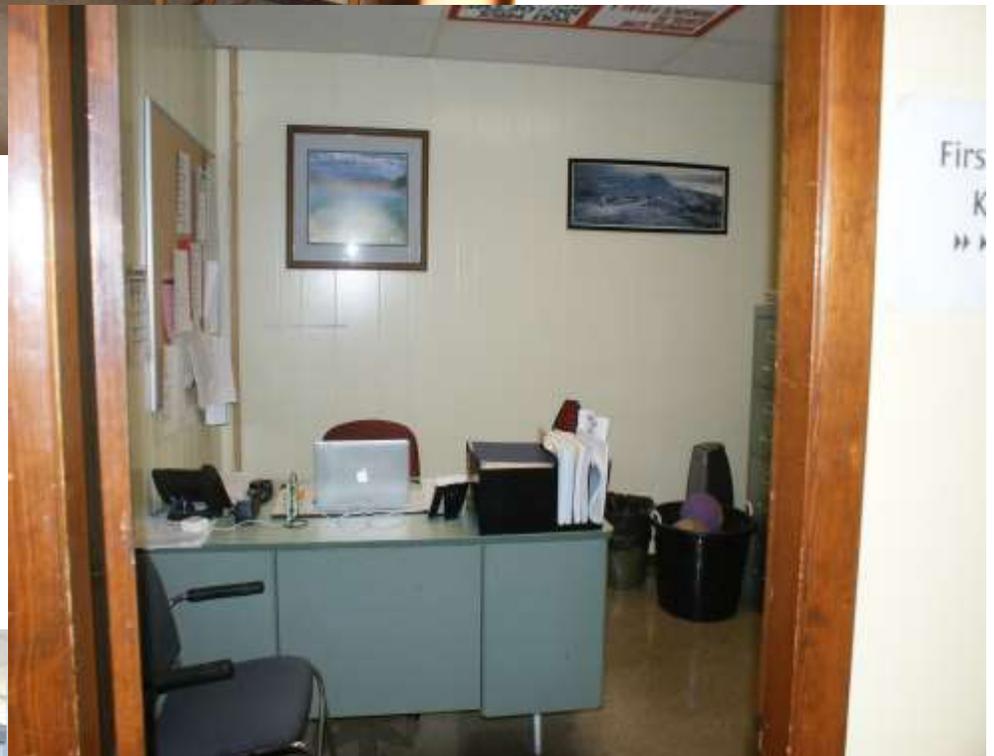
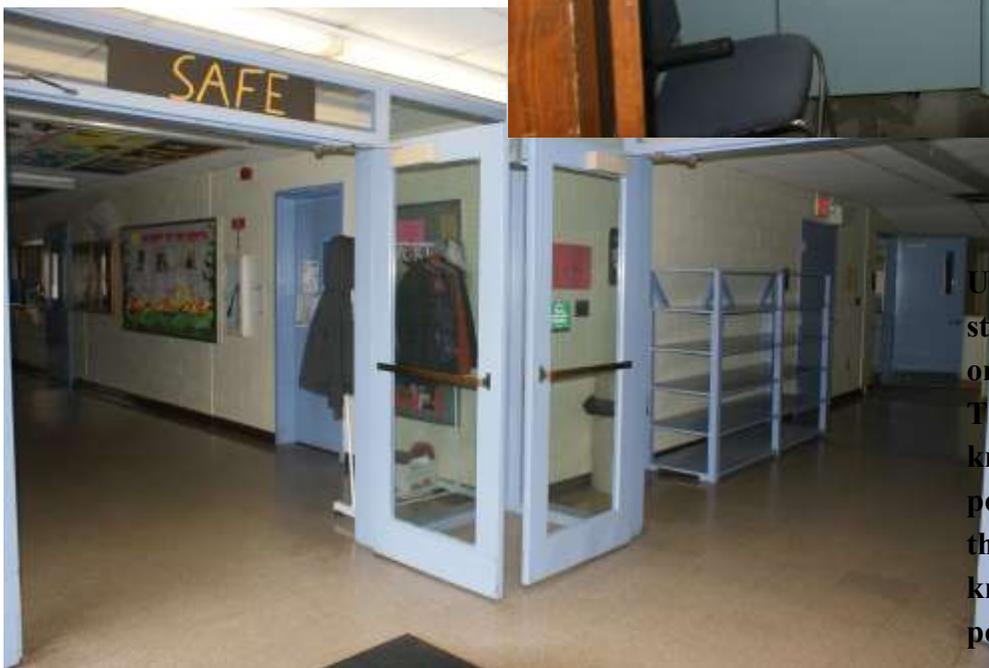
**Unsecured main entry. At times students will open door for someone if they are outside waiting. The secretary has no way of knowing when that has happened. If a parent is buzzed into the building you have no way of knowing what direction that this person may have gone in.**

**The 1928 H.B. Smith boiler and heating pipes are encased with asbestos. The boiler is considered the back up boiler in the event that the 2006 boiler fails. It would take at least 24-48hrs to bring the boiler on line along with a huge amount of repairs.**
