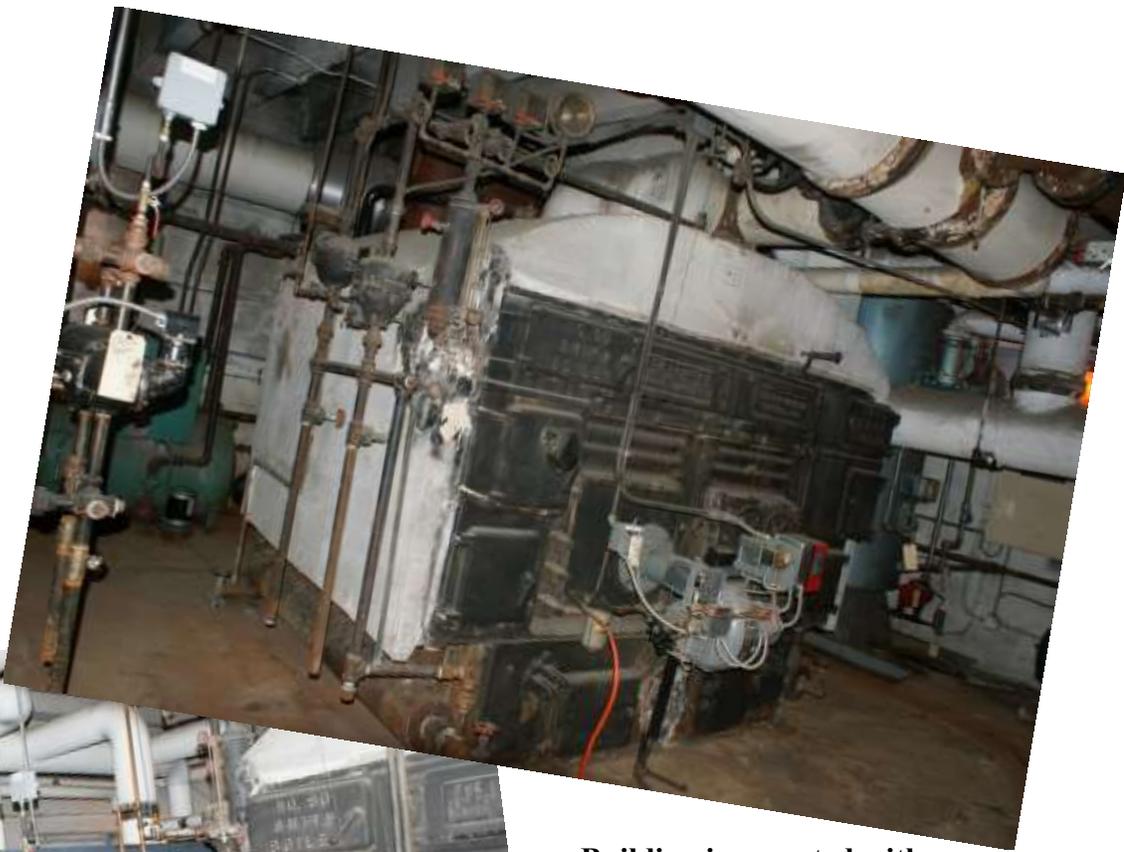
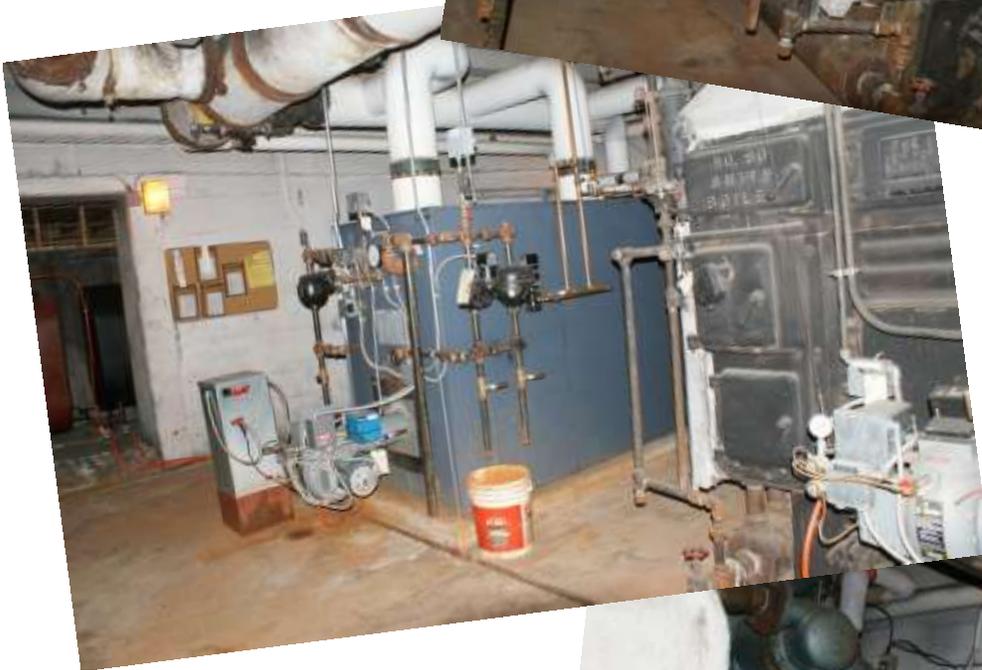
**Building is operated with one boiler that was installed in 2006. This boiler creates hot water and steam heat for the building. This supplies the hot water to the domestic system also.**

**The pneumatic heating control system is outdated and sometimes unreliable. It's very difficult to manage the heating schedule and controls. The heat plant and building is not energy efficient.**

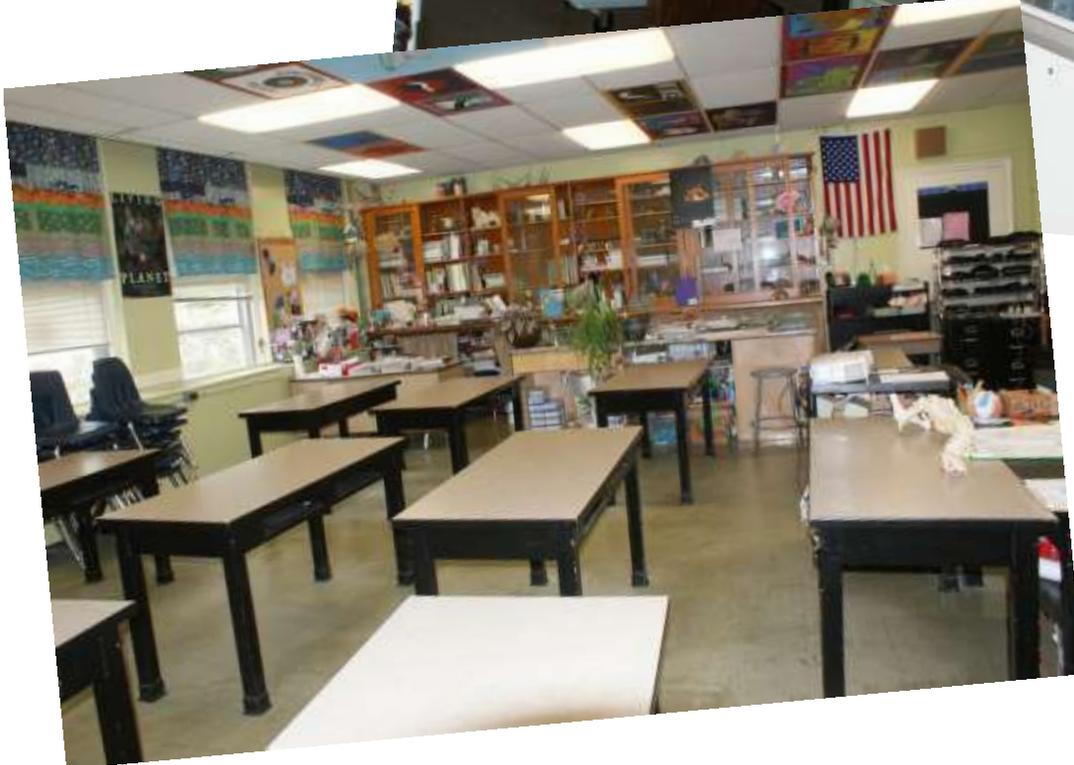
The one and only Science lab has one sink at the teachers station. The room is cramped with a small amount of storage area.

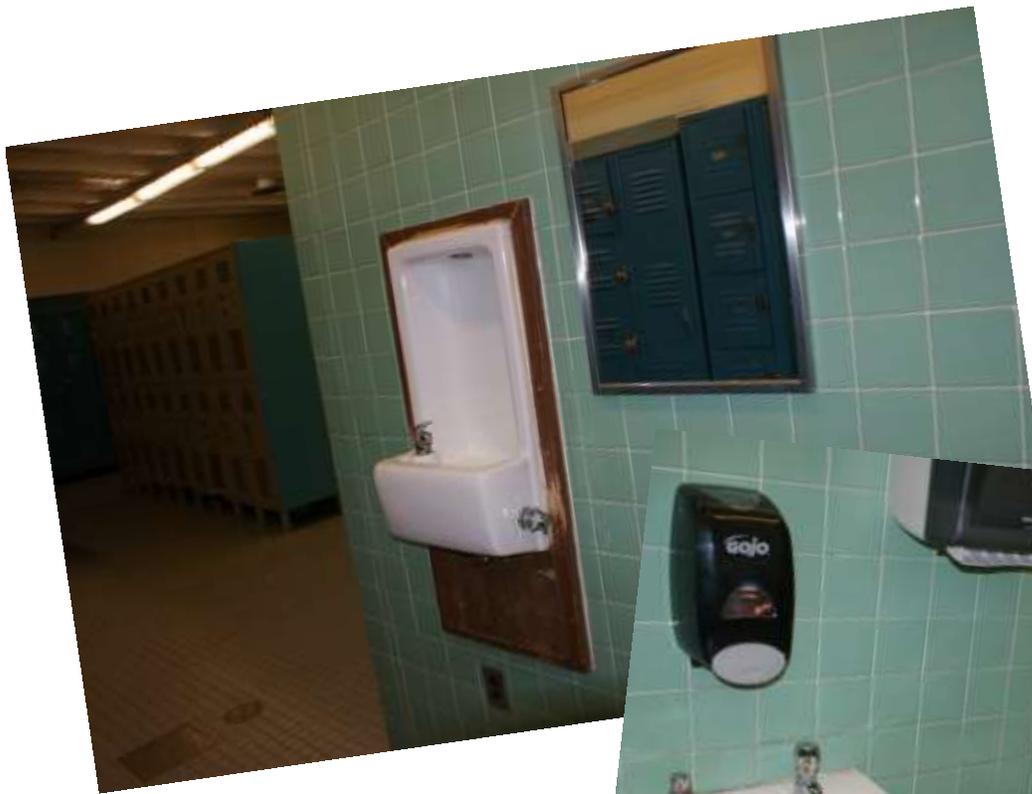
It's not uncommon for the mop sinks, hand sinks and or water fountains to be all in the same location in different parts of the building. There is no filtered or chilled water at most locations.

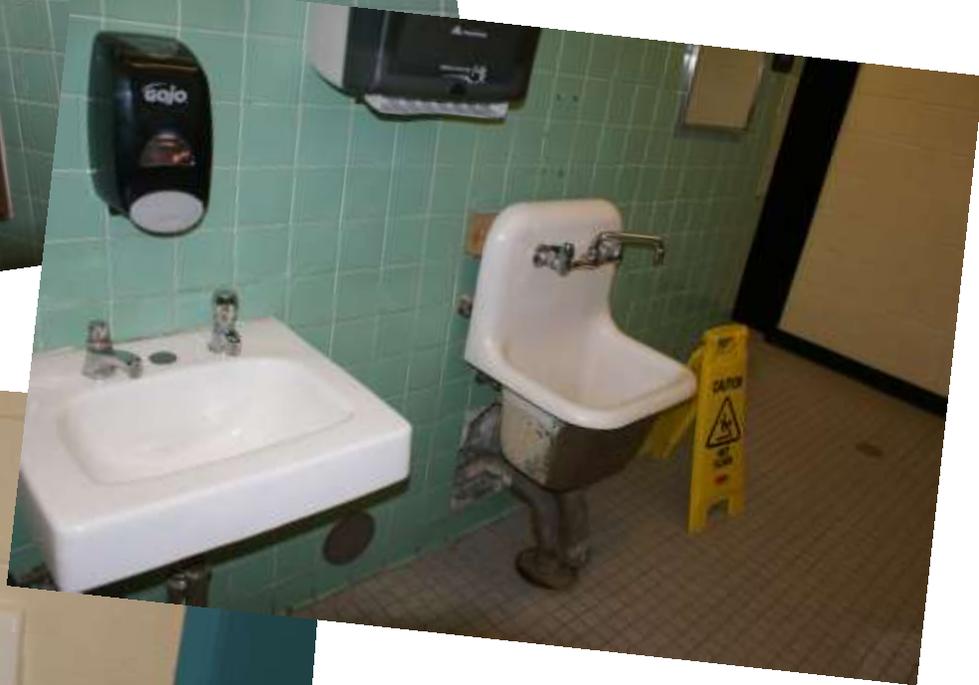
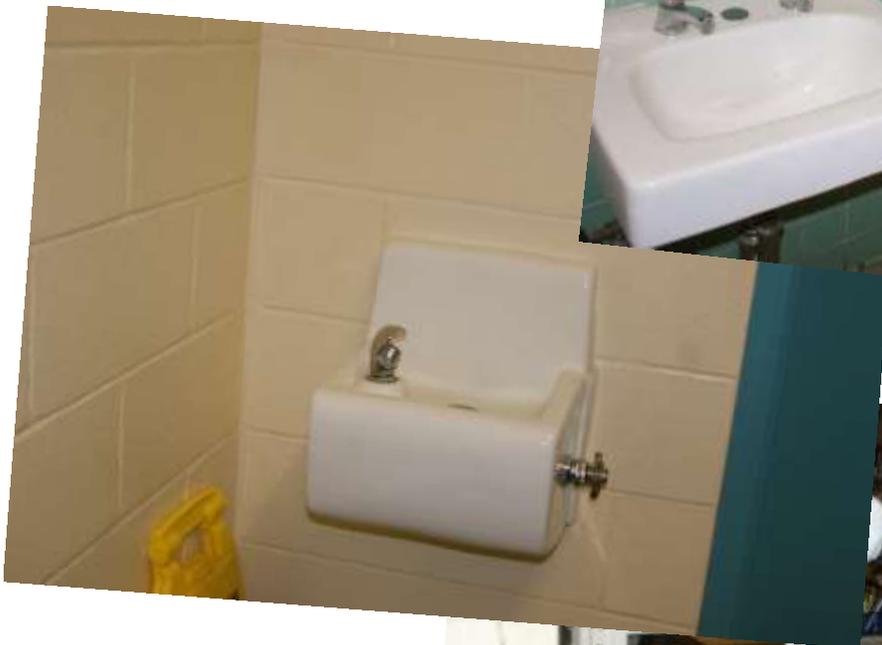
Custodians need to lift heavy pails of water to dump in their mop sinks. Most pails contain 3-5 gallons of water. Floor machines are emptied into pails at times so they can be dumped into the sinks.

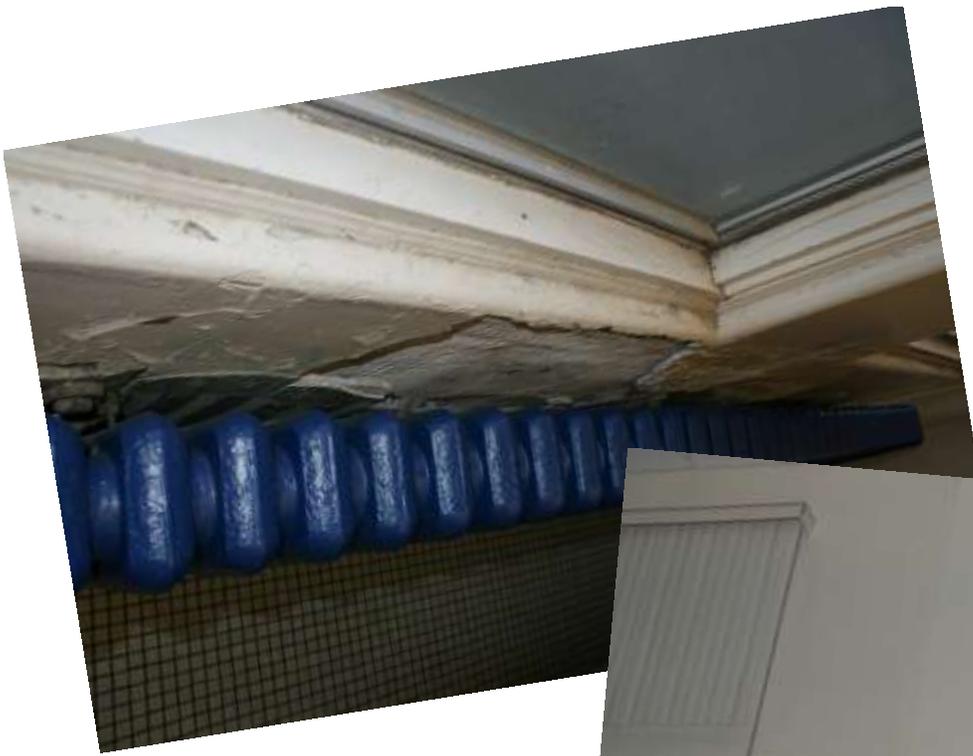
**Interior plaster behind the steam registers are deteriorating due to age and excessive heat and moisture.**

**The plaster in the auditorium has been blistering and flaking. Have had the area repaired several times.**

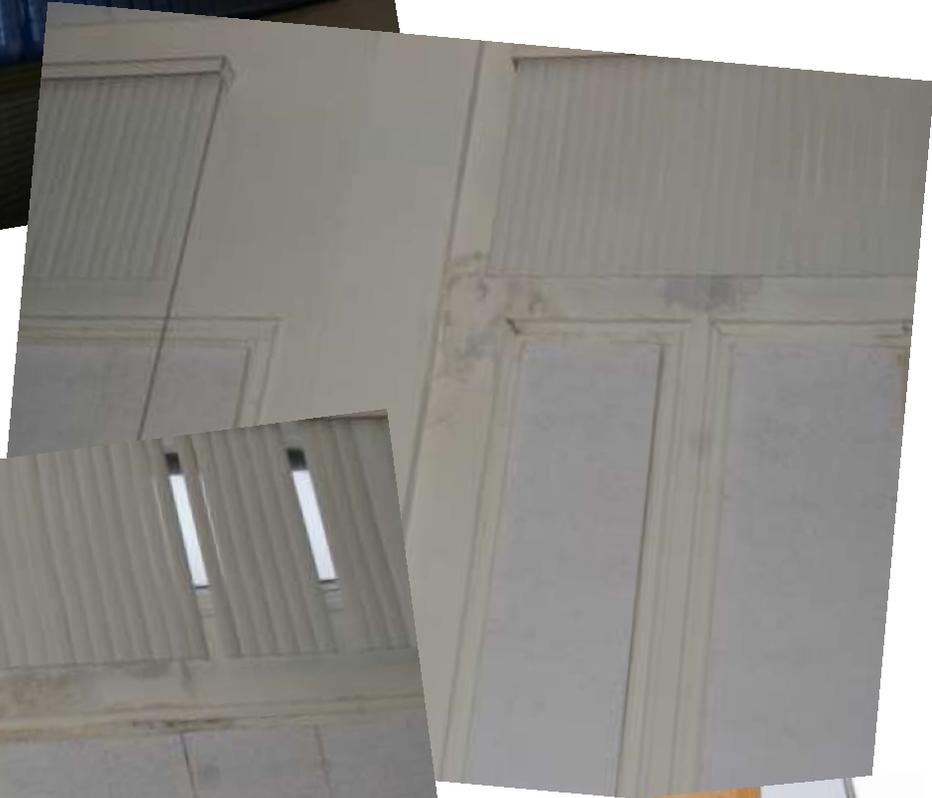
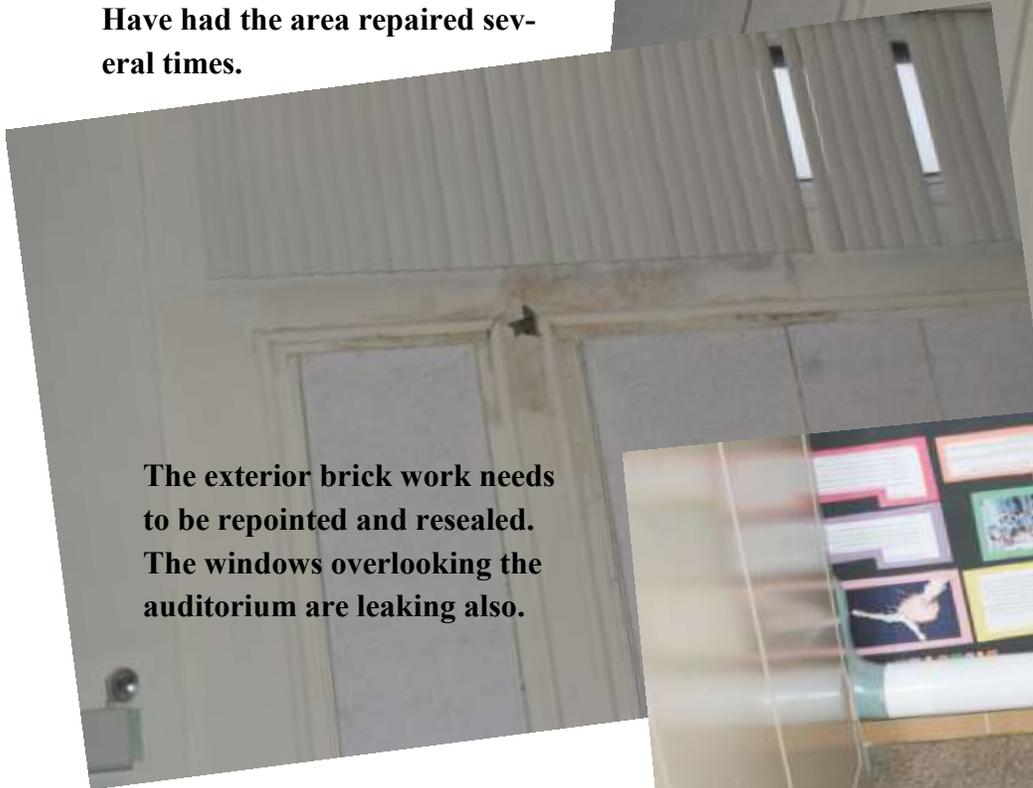
**The exterior brick work needs to be repointed and resealed. The windows overlooking the auditorium are leaking also.**

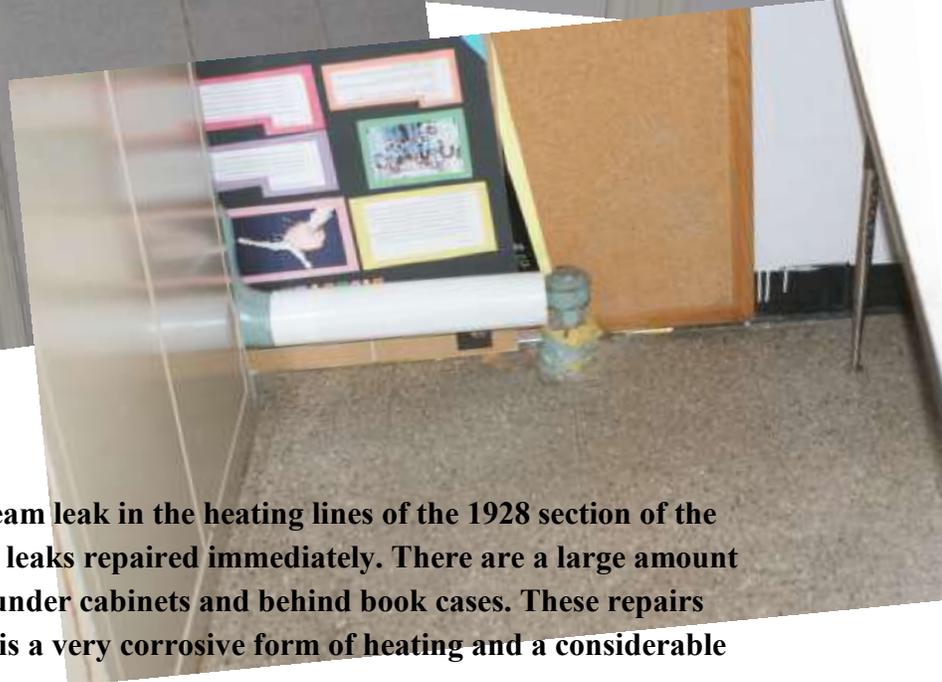
**Occasionally there will be a steam leak in the heating lines of the 1928 section of the building. We have the exposed leaks repaired immediately. There are a large amount of steam lines that are buried under cabinets and behind book cases. These repairs tend to be quite costly. Steam is a very corrosive form of heating and a considerable amount of maintenance.**
