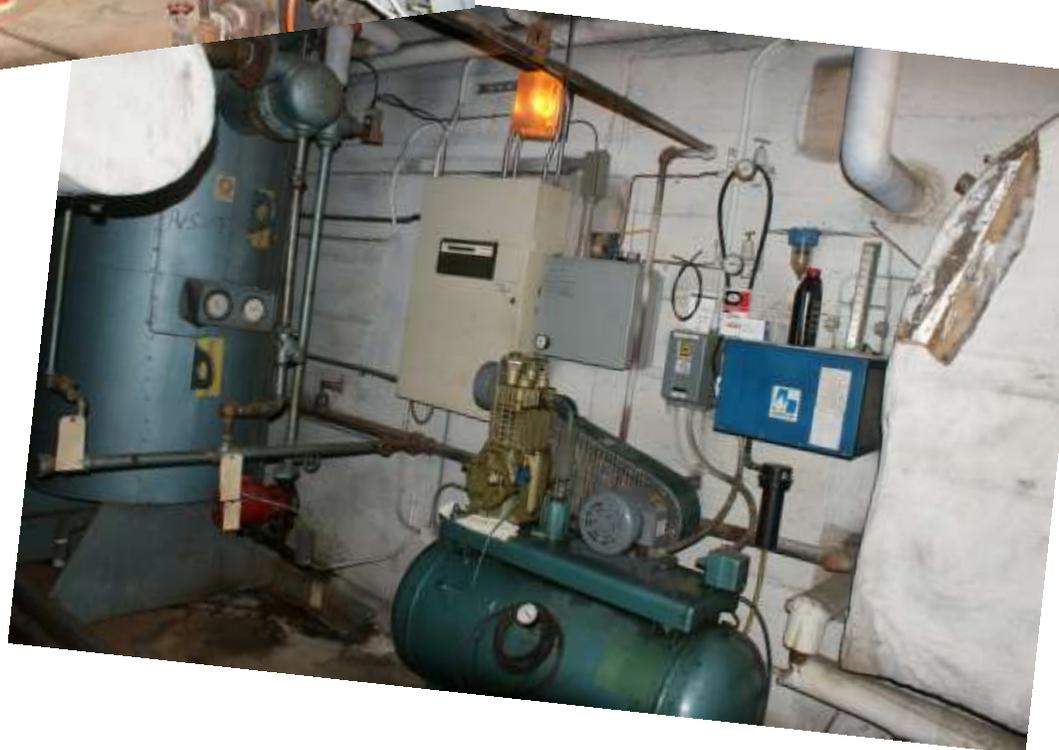
**The pneumatic heating control system is outdated and sometimes unreliable. It's very difficult to manage the heating schedule and controls. The heat plant and building is not energy efficient.**

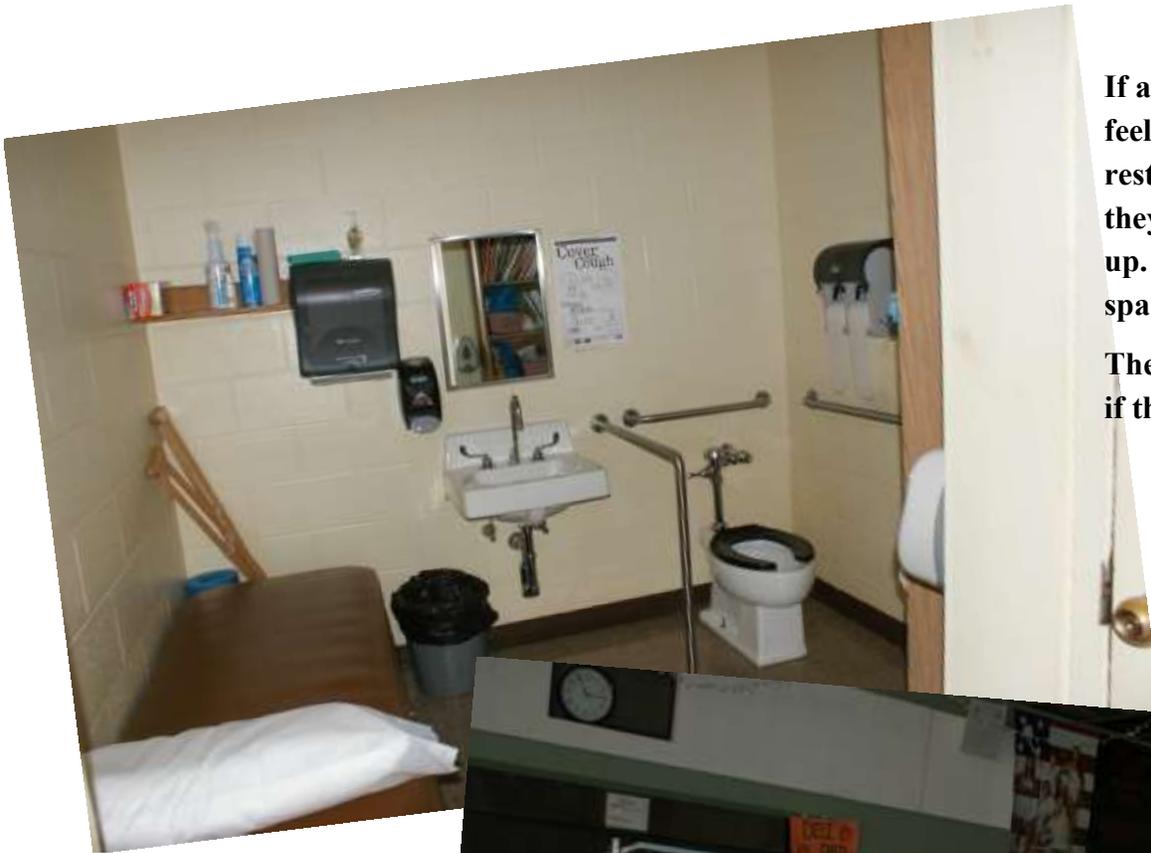
If a student is ill and doesn't feel well they lay down and rest in the bathroom while they're waiting to be picked up. There are no other spaces available.

They have to leave the room if this space is needed.

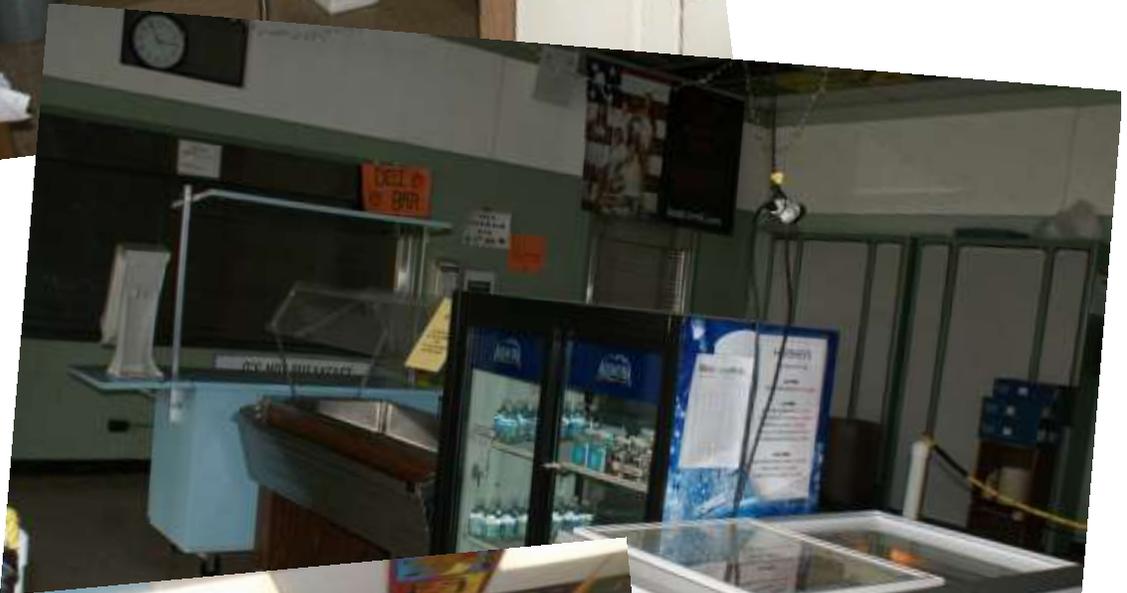
A make shift lunch line consumes a large portion of the cafeteria. The original configuration from 1972 is no longer functional with today's Breakfast and lunch time standards.

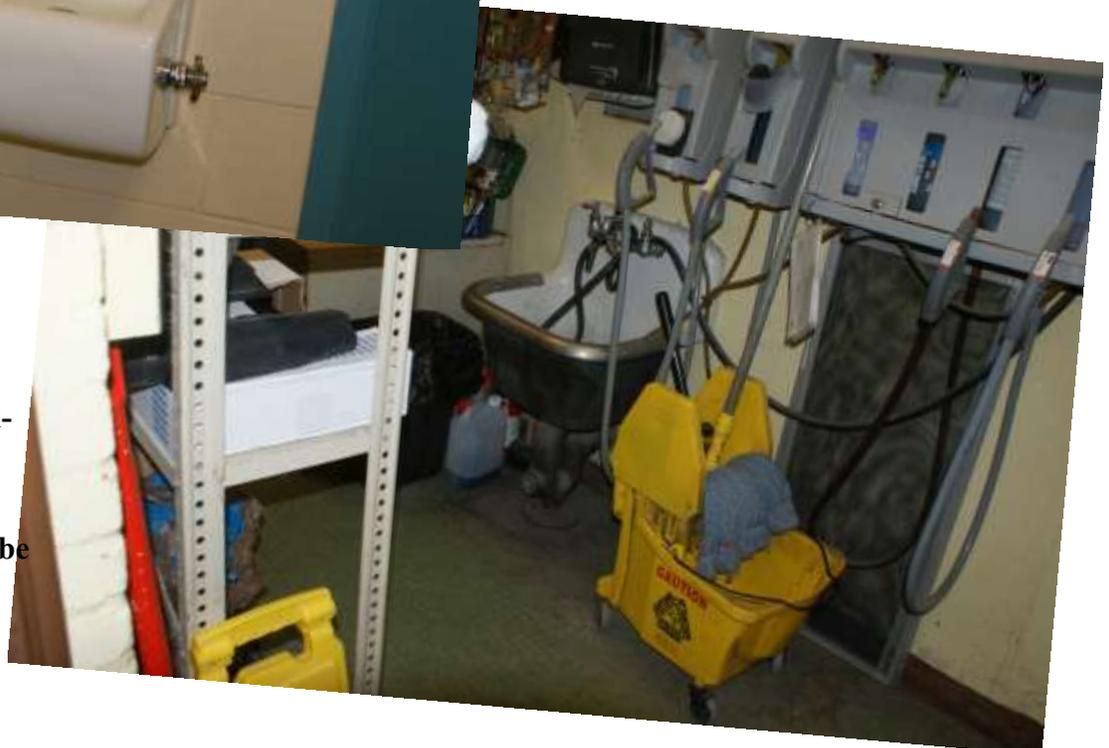
Custodians need to lift heavy pails of water to dump in their mop sinks. Most pails contain 3-5 gallons of water. Floor machines are emptied into pails at times so they can be dumped into the sinks.
